Bayside Cobble Berm Nourishment

Project Overview

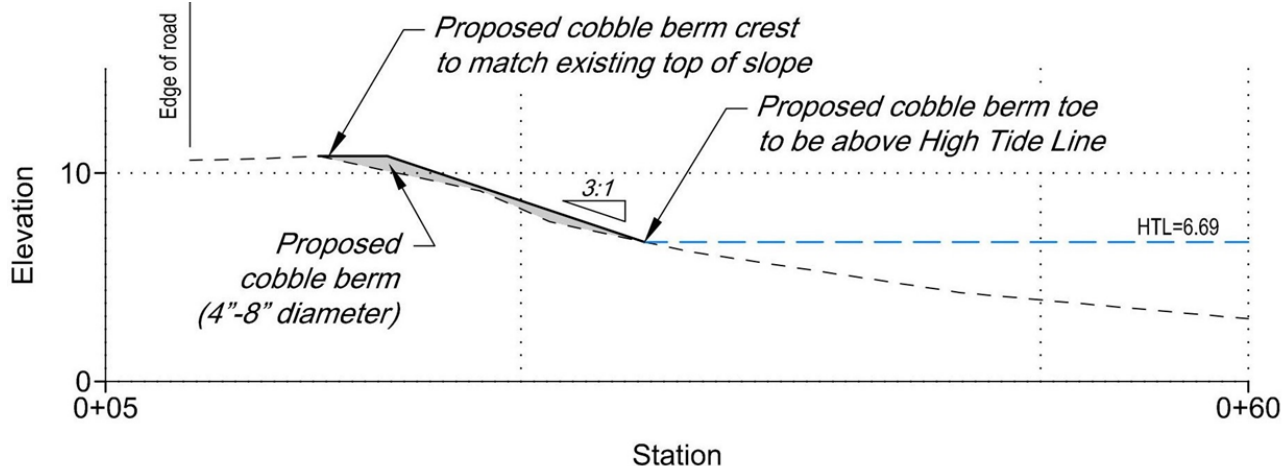
TRANSECT BSCB 2

One of several berm profiles used to renourish the bayside cobble berm on Duxbury Beach. During the design process, it was important to keep the toe of the berm above the high tide line to expedite permitting and keep material out of the swift moving channel.

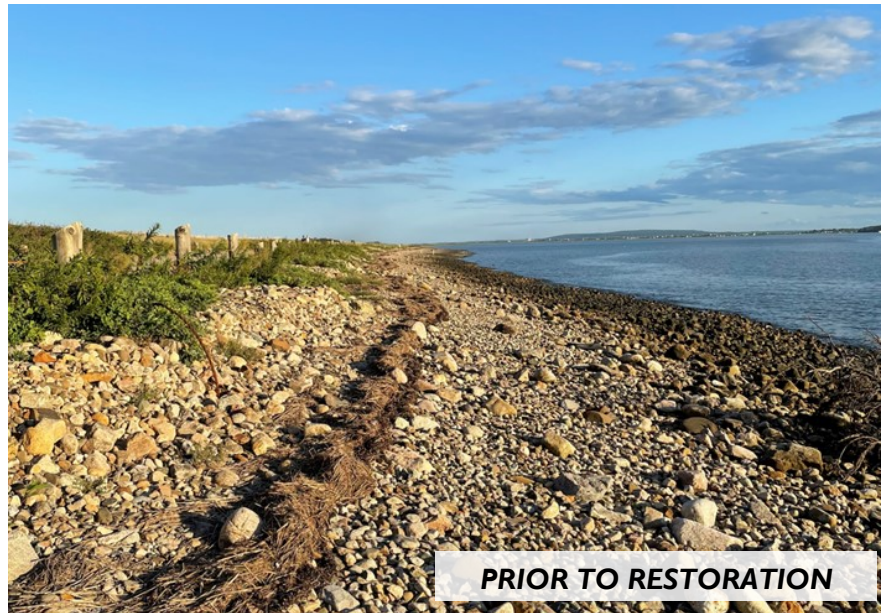
PRIOR TO RESTORATION

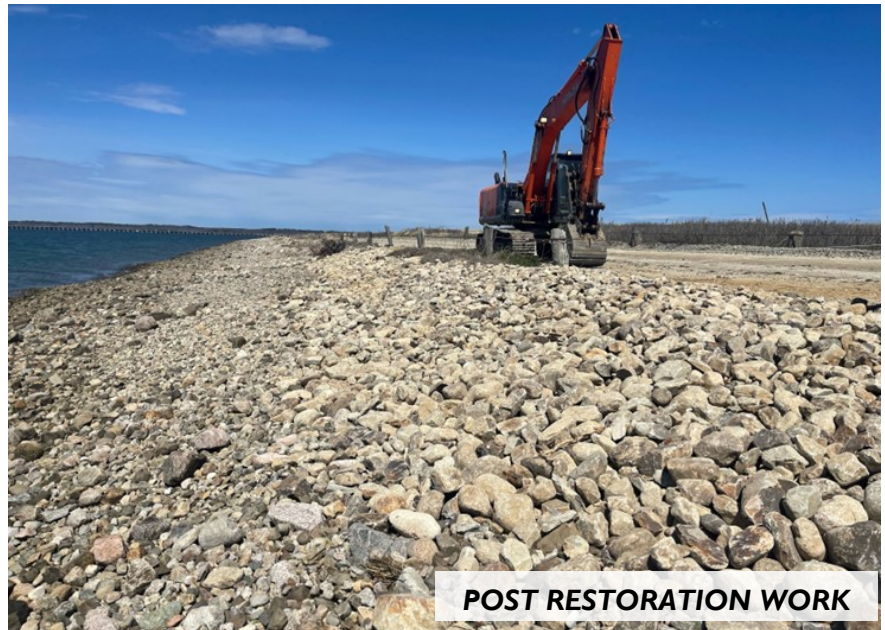
POST RESTORATION WORK
